# **Soyuz Inspection**

## **ISIW-2017**

XI4 / Image Science and Analysis Group  
Michael Rollins, ISAG (XI4), Jacobs Technology  
Randy Moore, ISAG (XI4), NASA  
Gary Kilgo, ISAG (XI4), Barrios Technology  
January 31, 2017

# Imagery Inspections of ISS-docked Soyuz

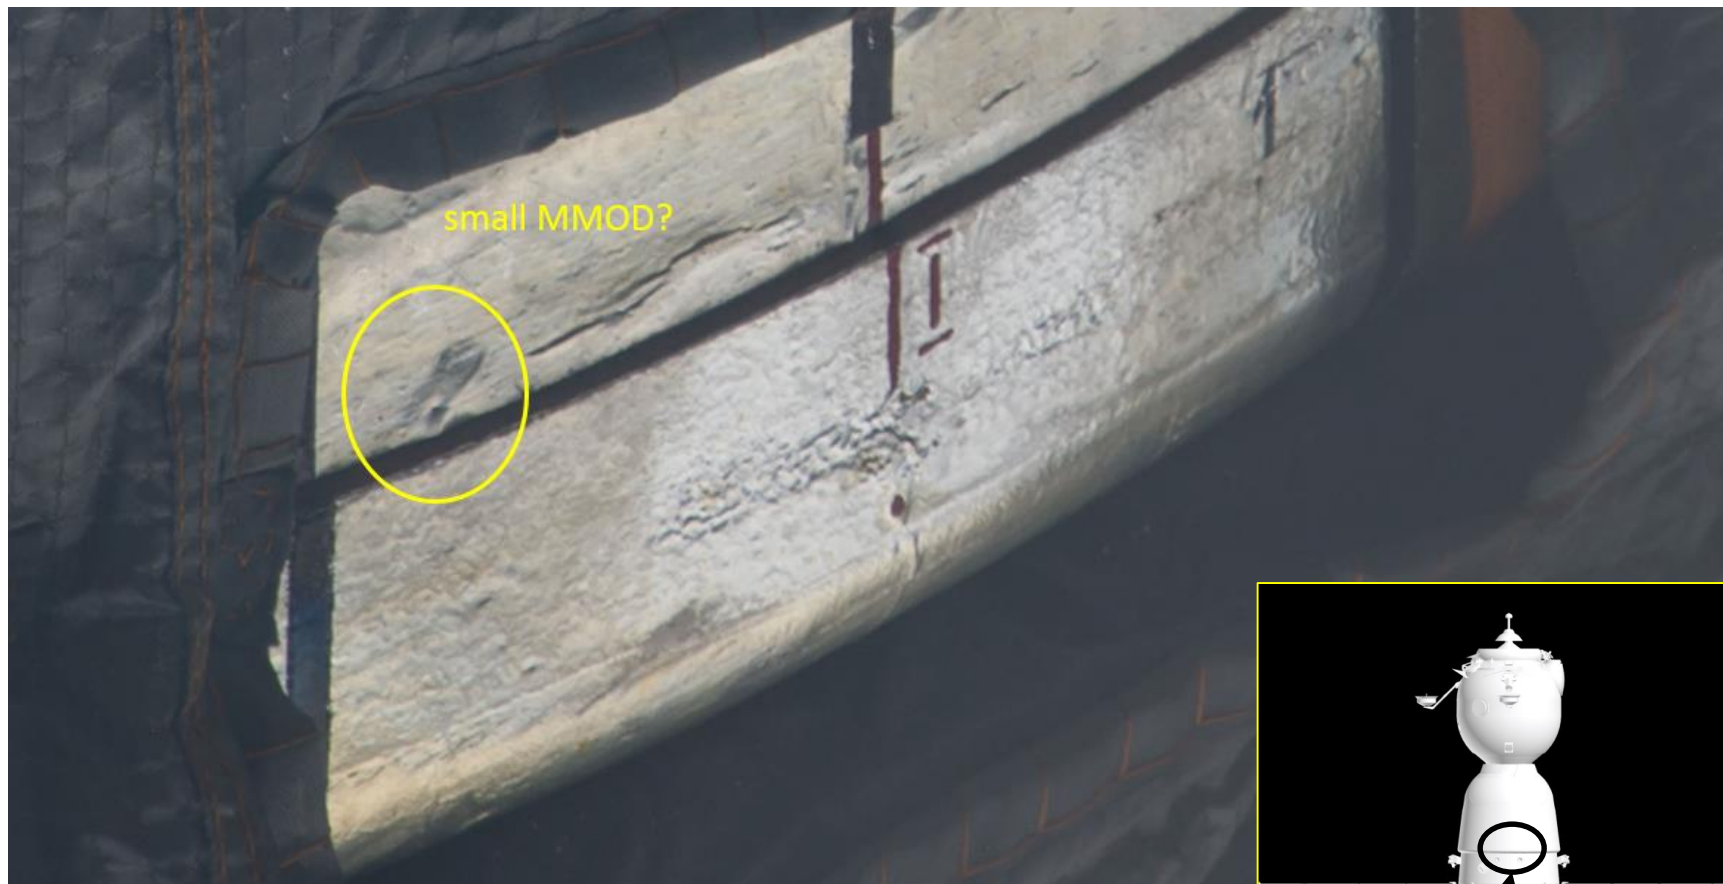
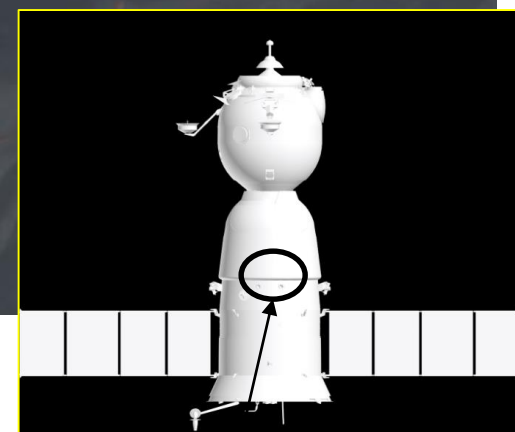
photo # iss049e028284

## Potential MMOD strike on Descent Module Surface

Approximate AOI Location

**A comparison with a very similar crew photo of AOI #1 region taken during docking approach could not confirm that AOI #1 was present on July 9.**

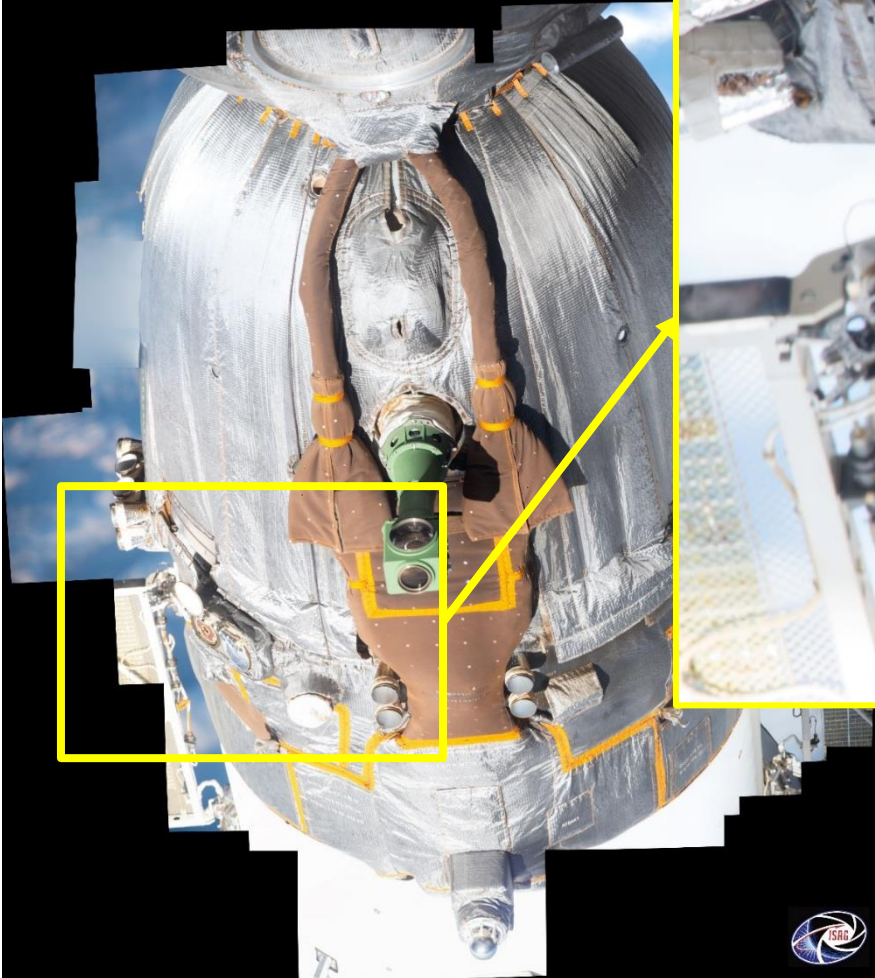
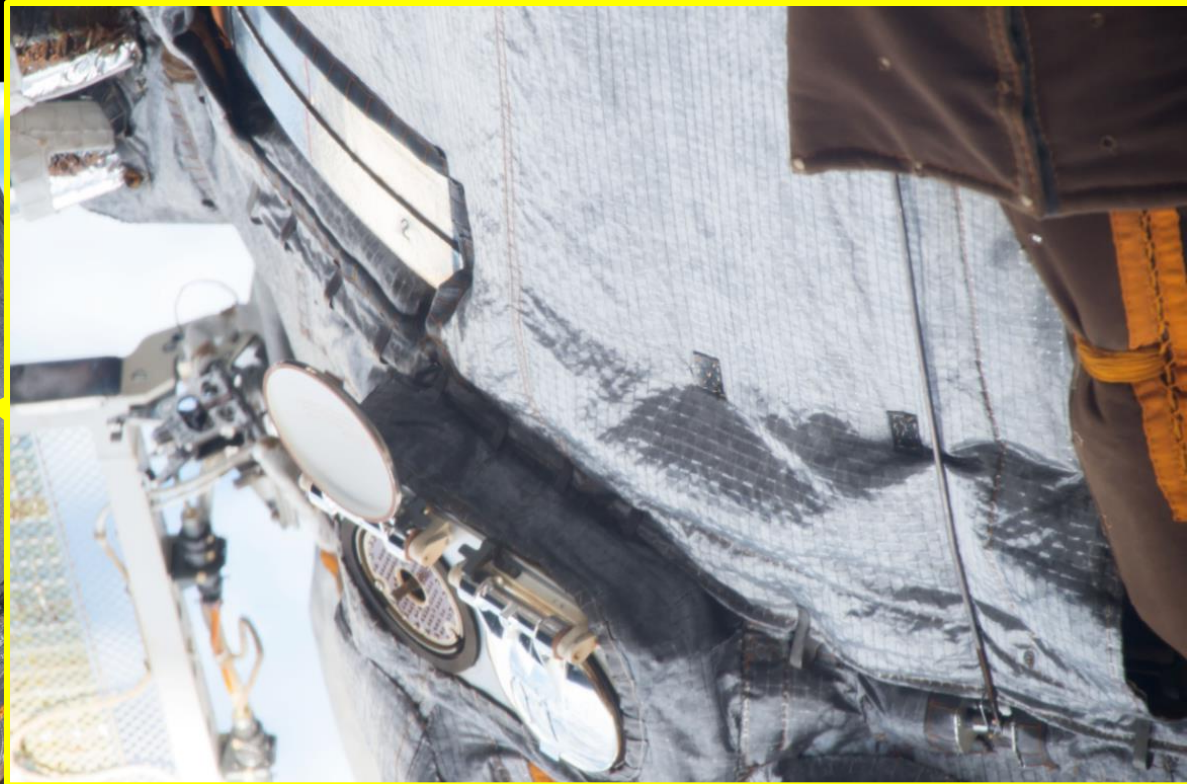
iss049e028232

# Open Valve Cover

Images of 47S from July 14 and subsequent also show this valve cover open. No images of this region prior to July 14 were found.

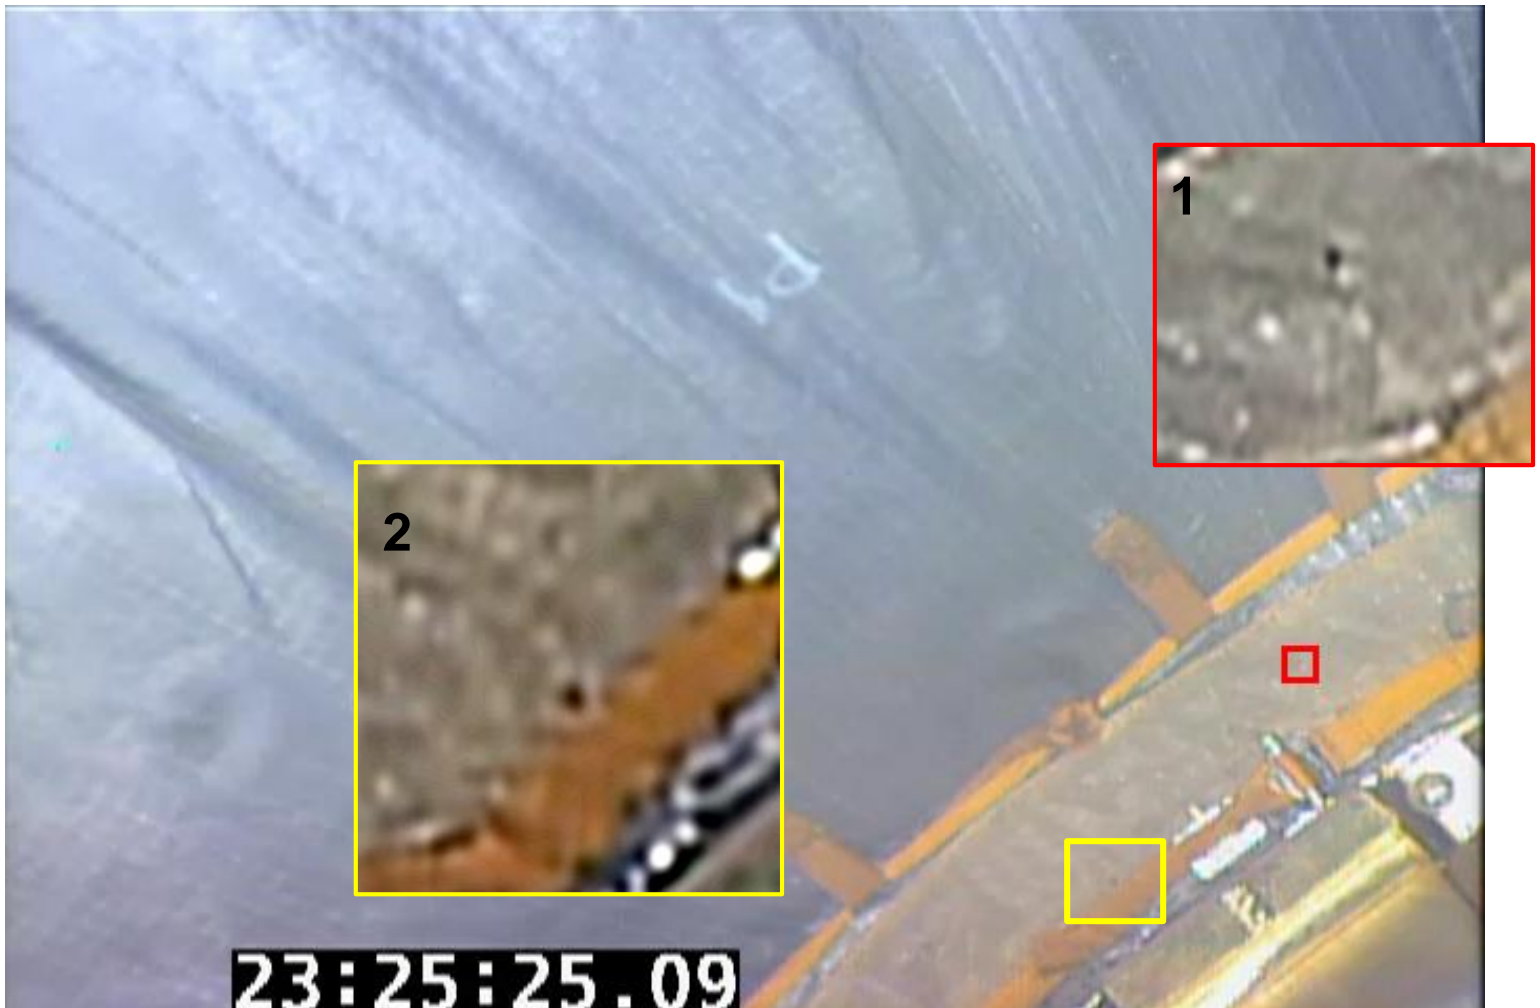
# Scan 3 ROI 1 and 2

Black spots, < 3mm diameter

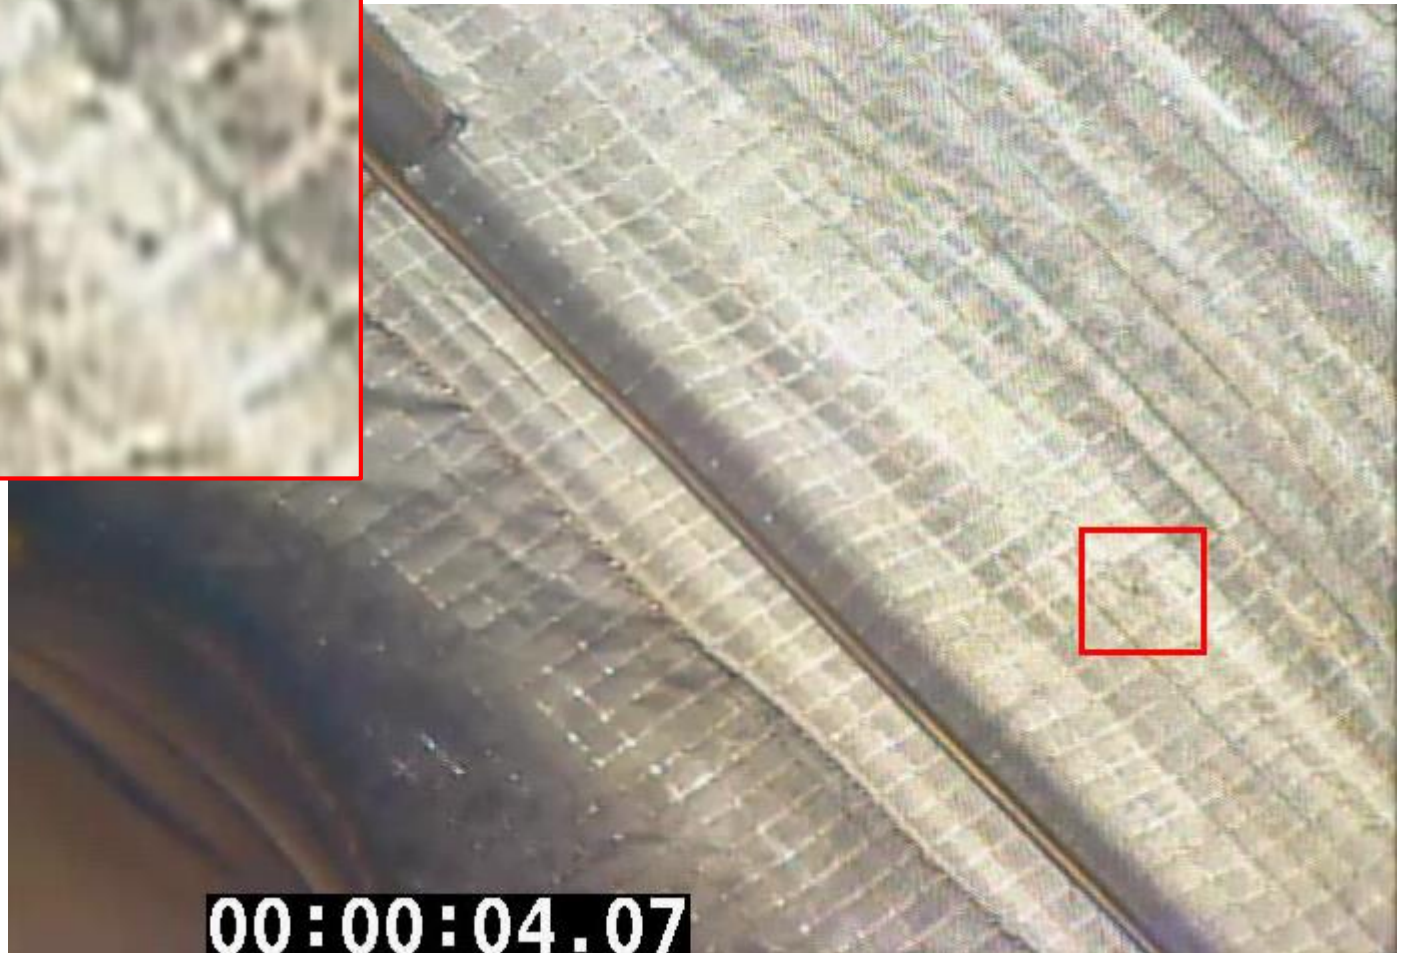
# Scan 6 ROI 1

Black spot, ~ 2.4mm x 1mm

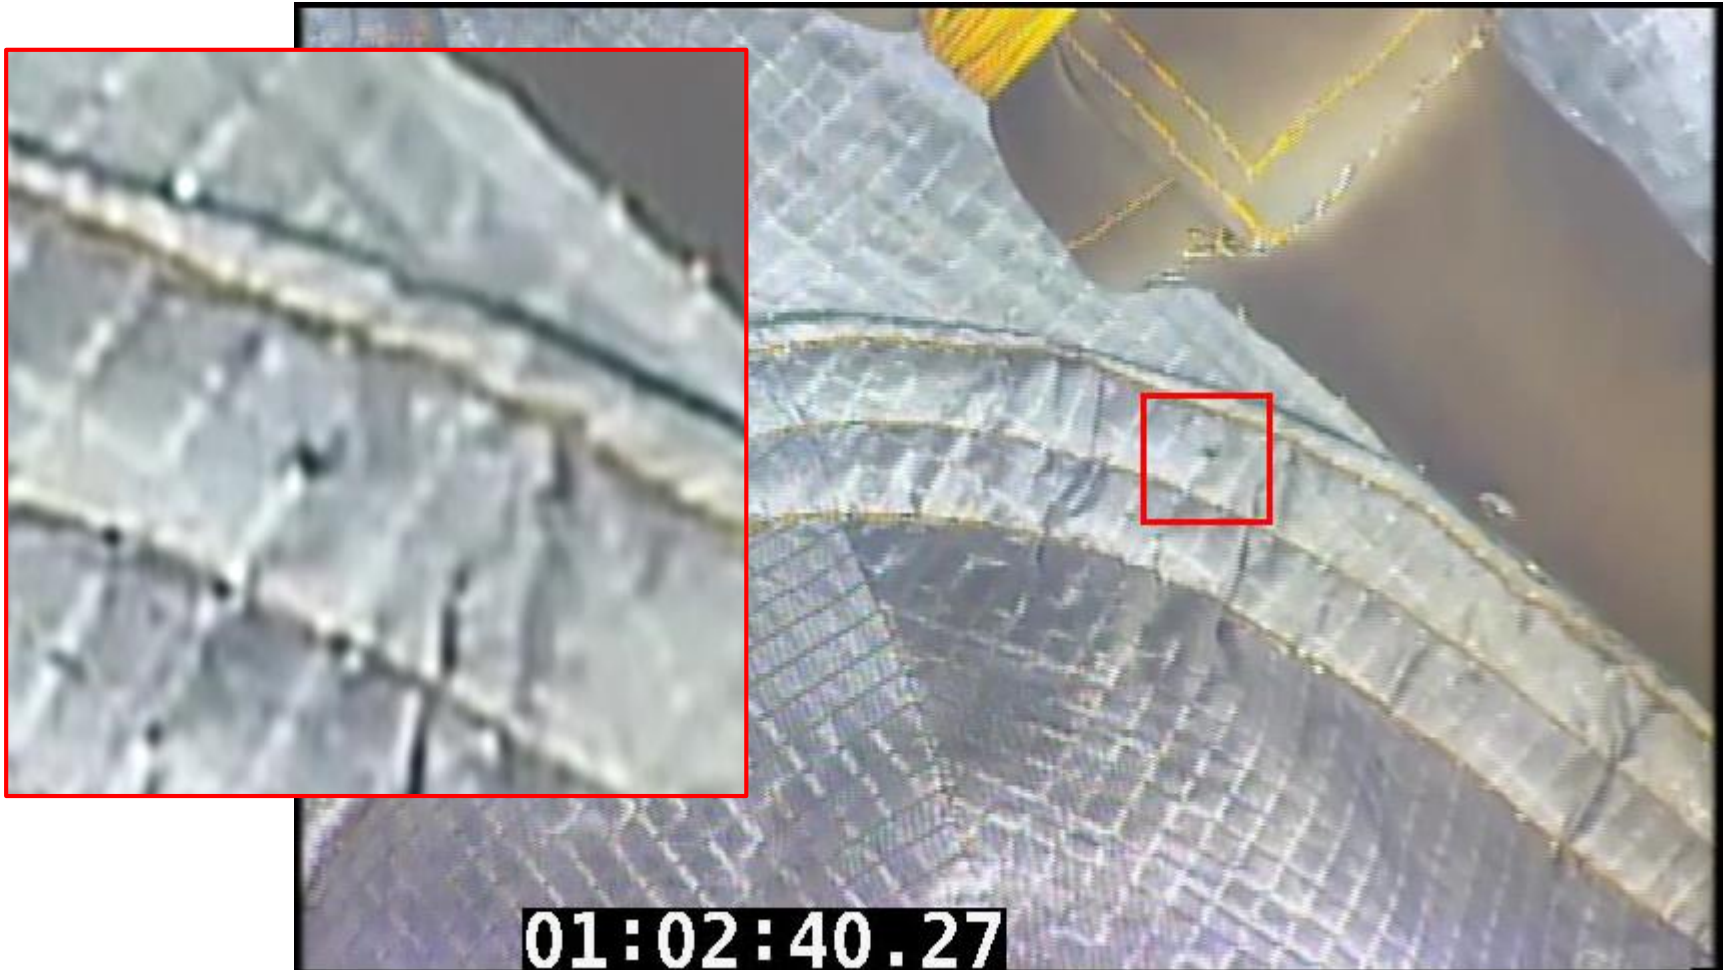
# Scan 7 ROI 1

Black spot, ~ 2.2mm x 1.7mm

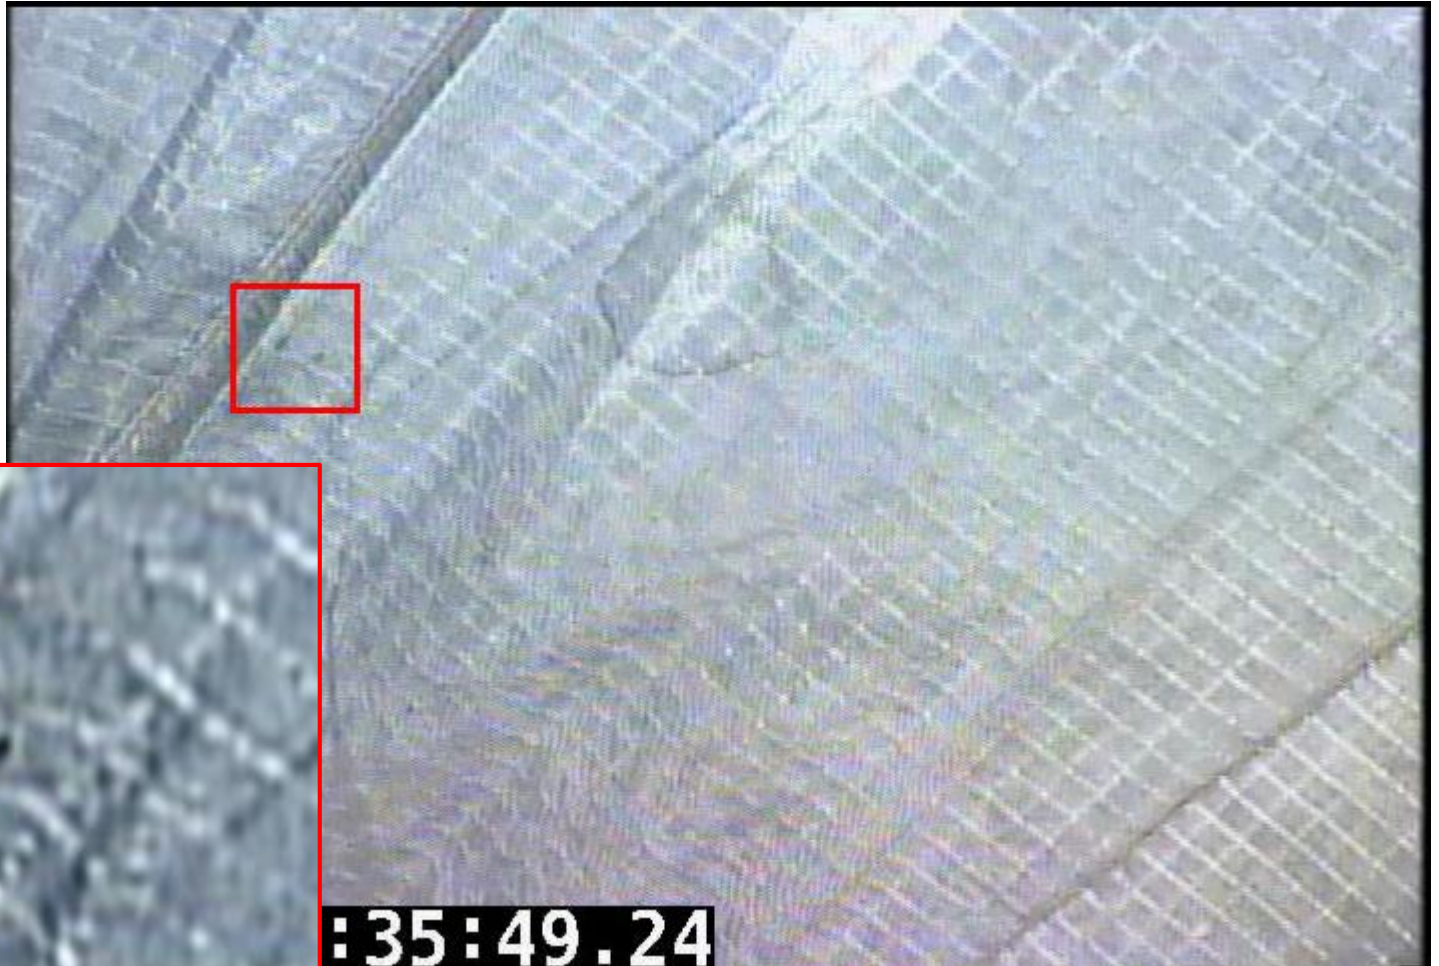
# Scan 11 ROI 1

Black spots, ~ 5.4mm and 3.8mm diameter

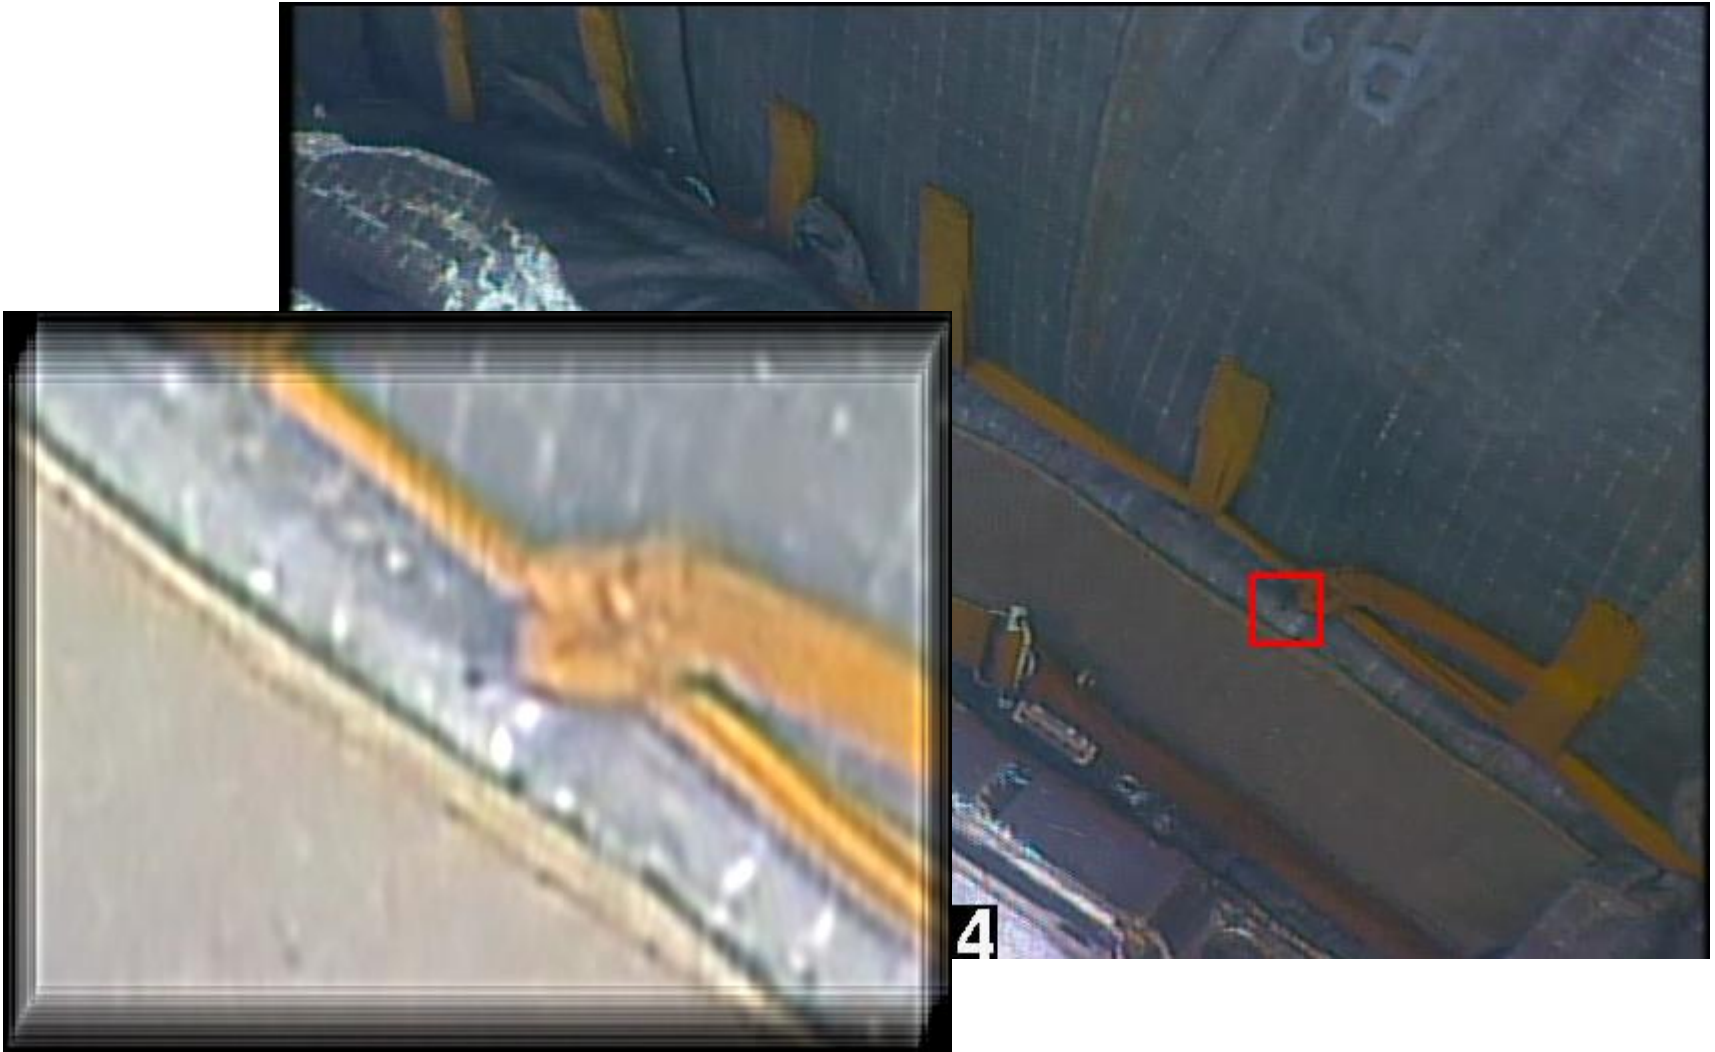
# Scan 12 ROI 1

Black spot, ~ 1.8mm diameter

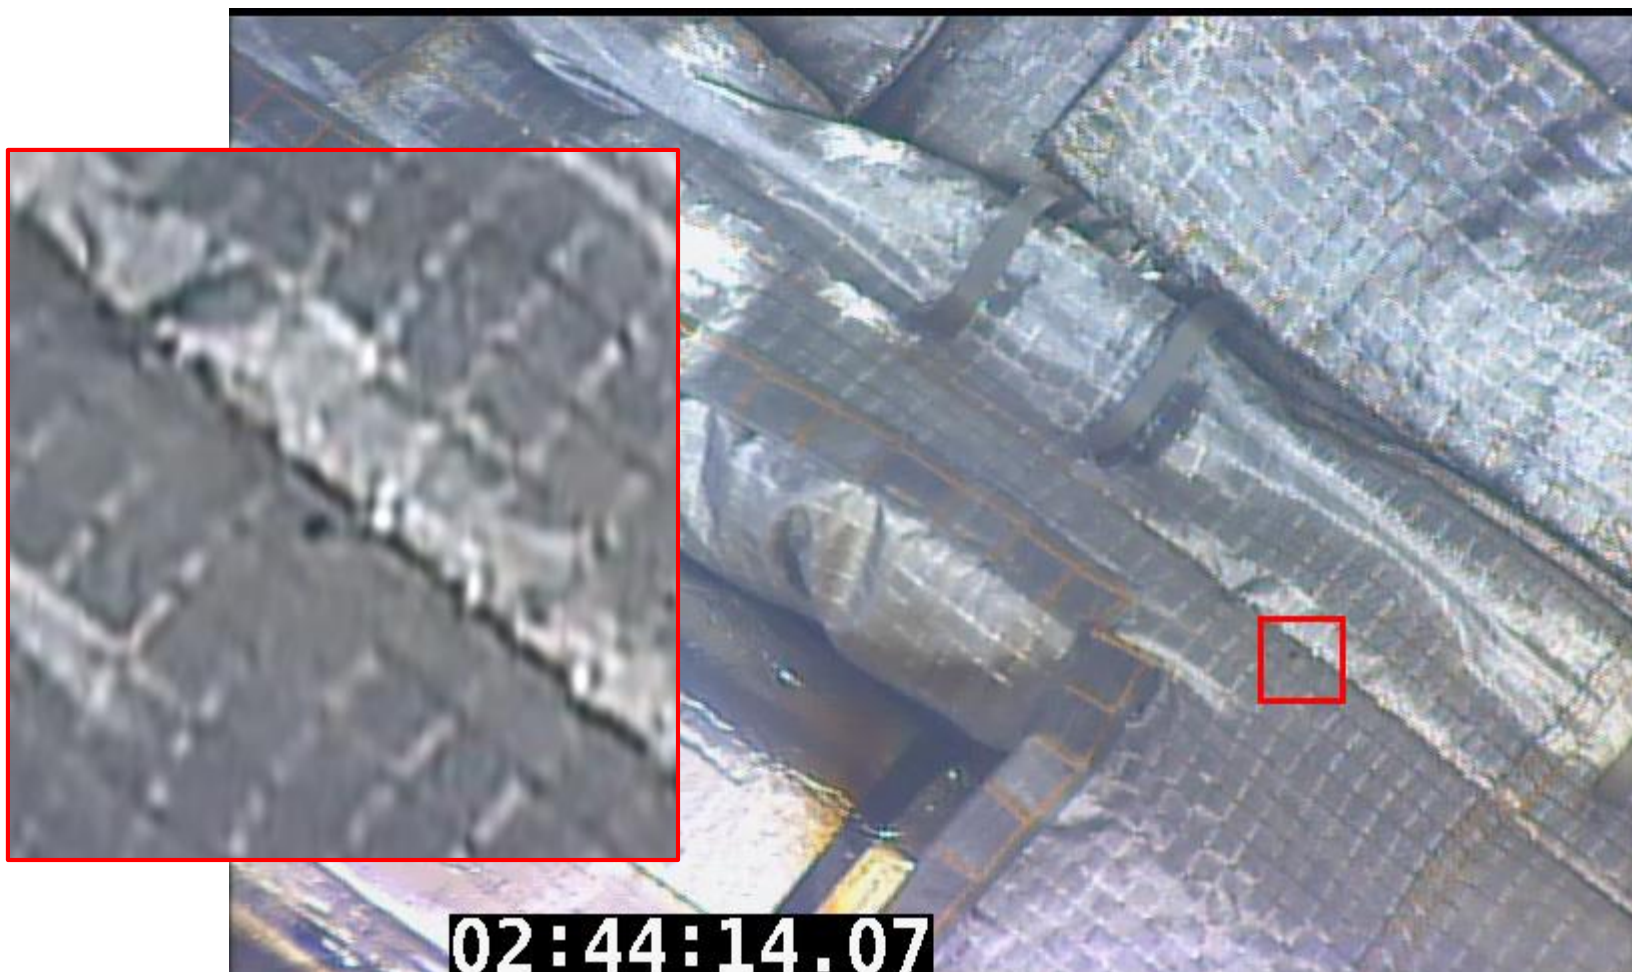
# Scan 12 ROI 3

Black spot, ~ 2.8mm x 3mm

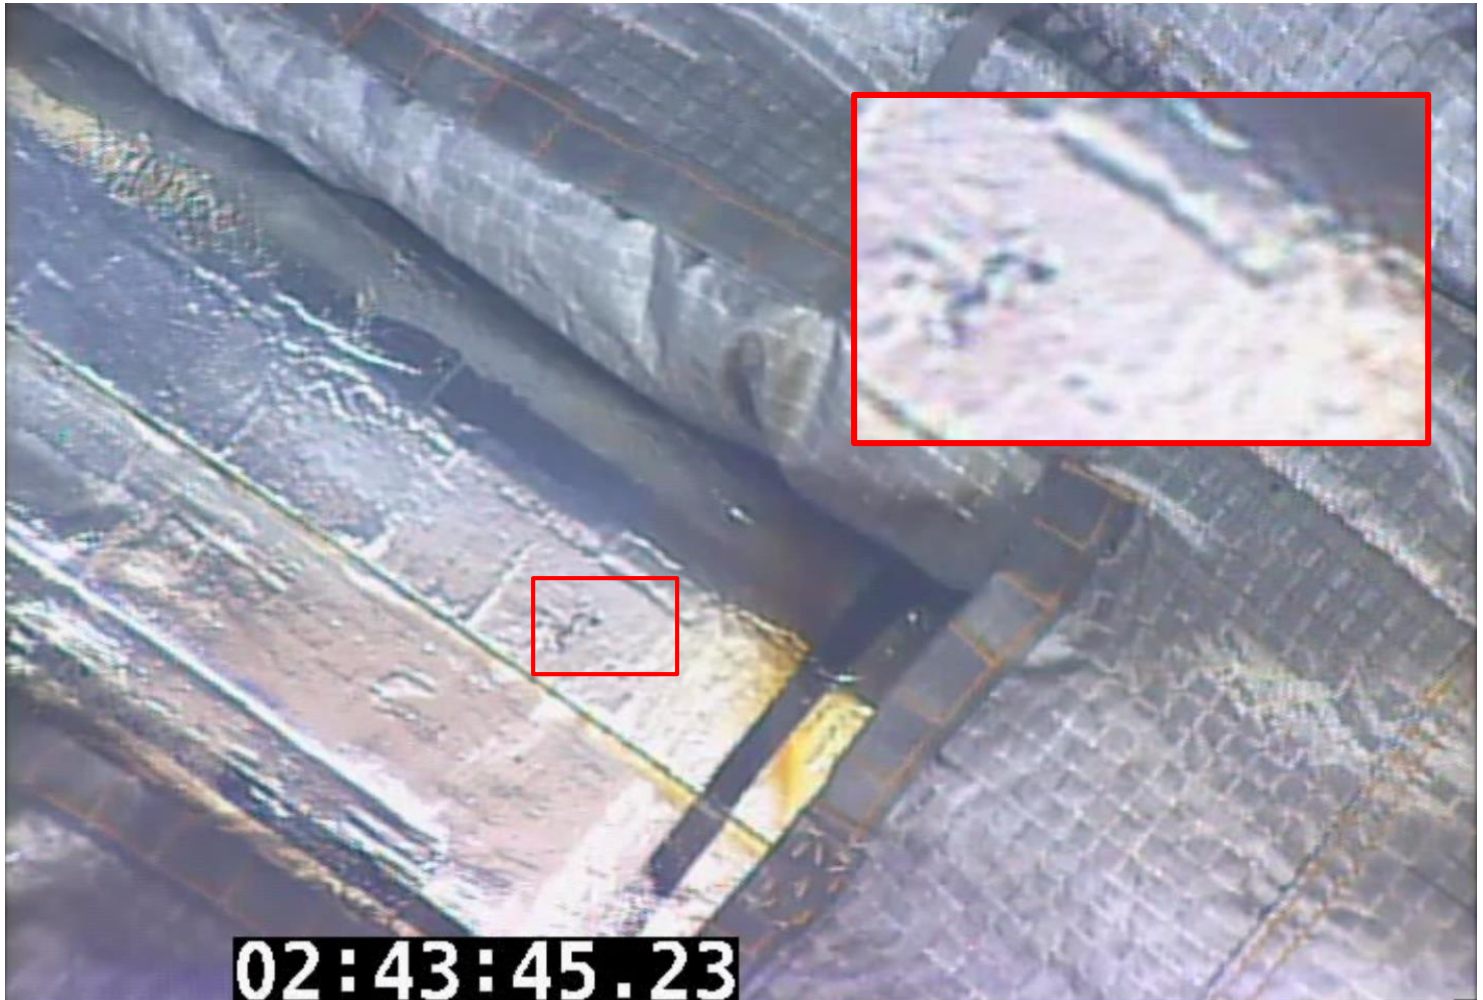
# Scan 12 ROI 4

Black spot, ~ 3mm

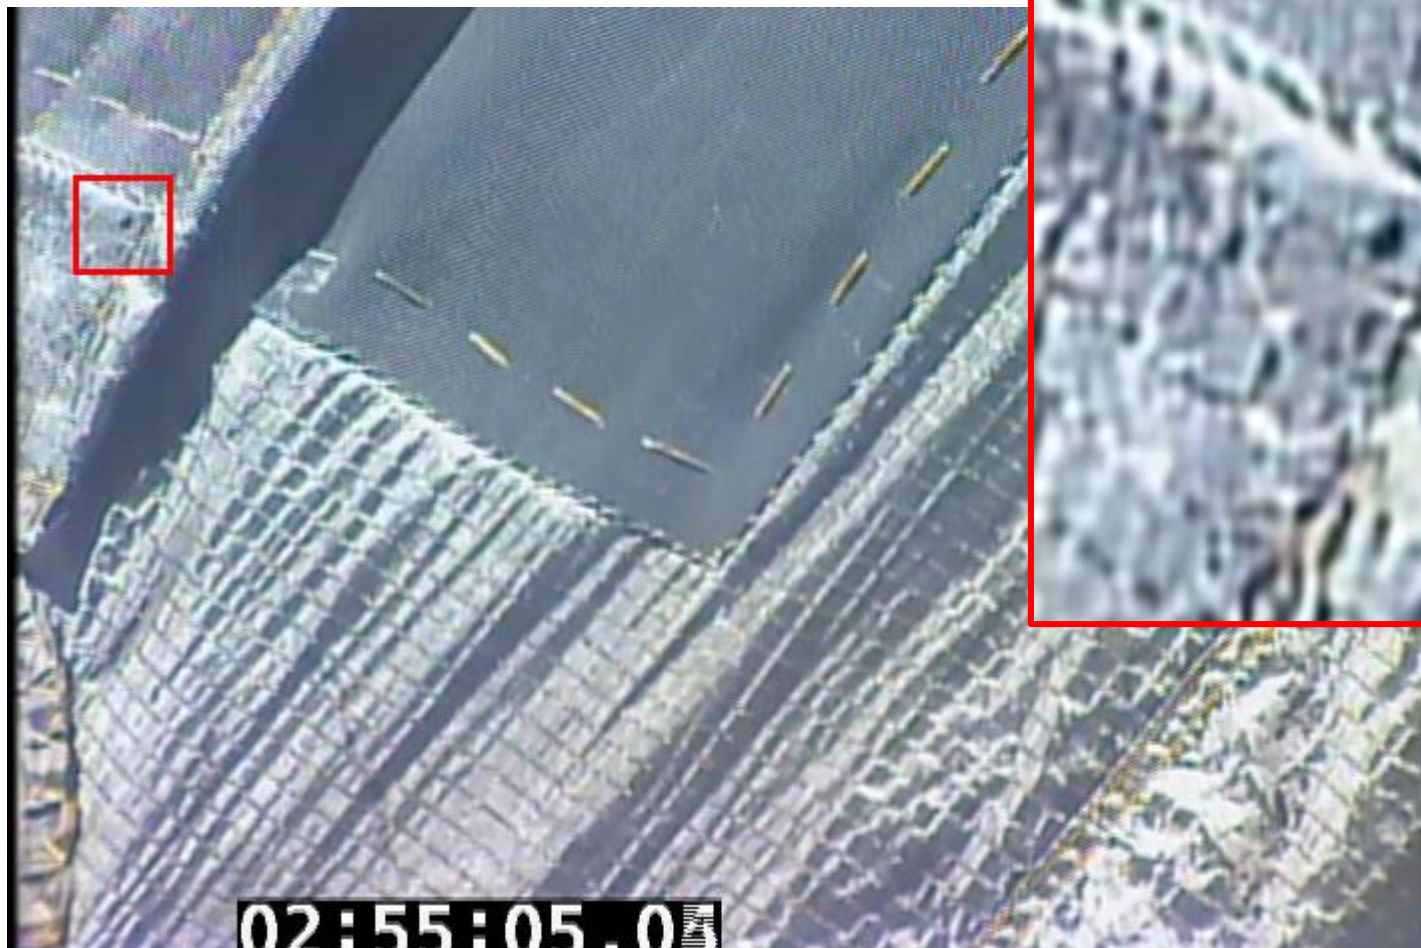
# Scan 13 ROI 1

Black spot, ~ 3.5 x 4.9mm

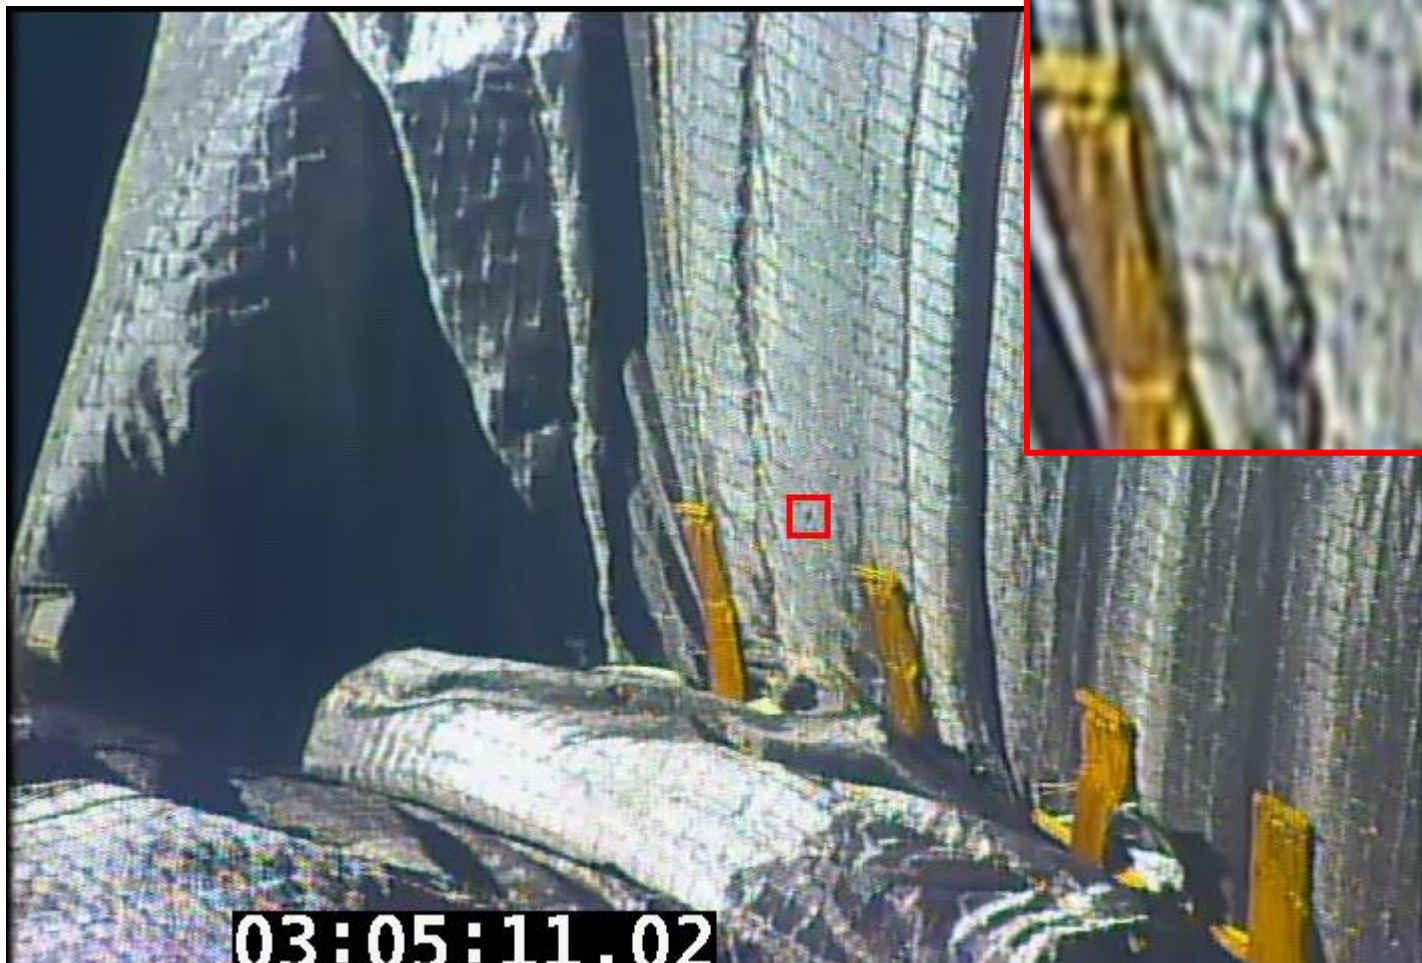
# Scan 14 ROI 1

Black spot, ~ 5.3mm diameter

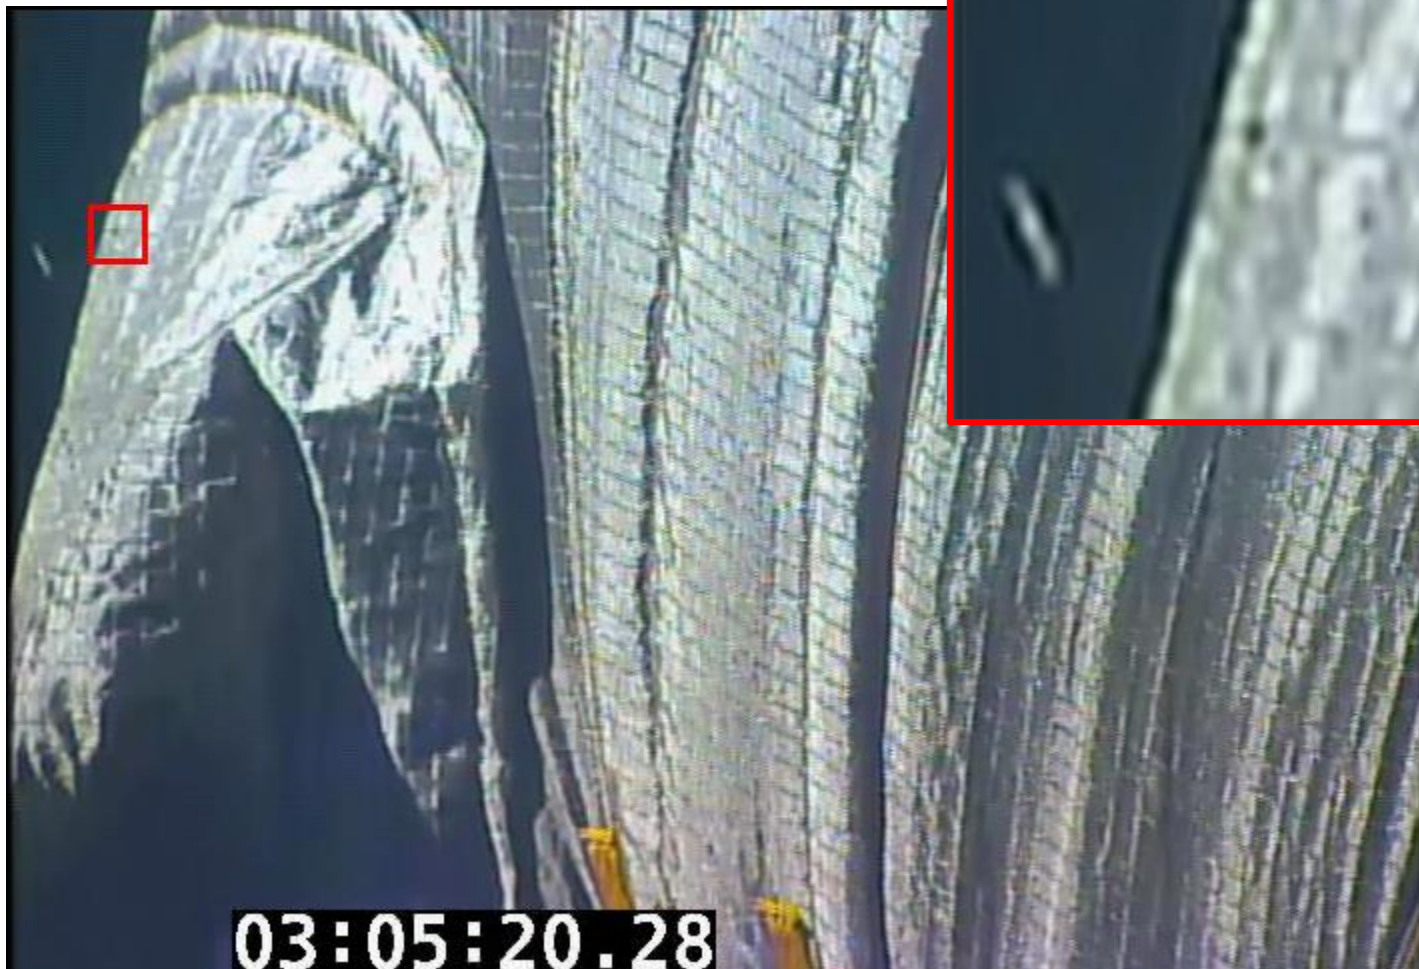
## Scan 14 ROI 2

Black spot, ~ 2.4mm diameter

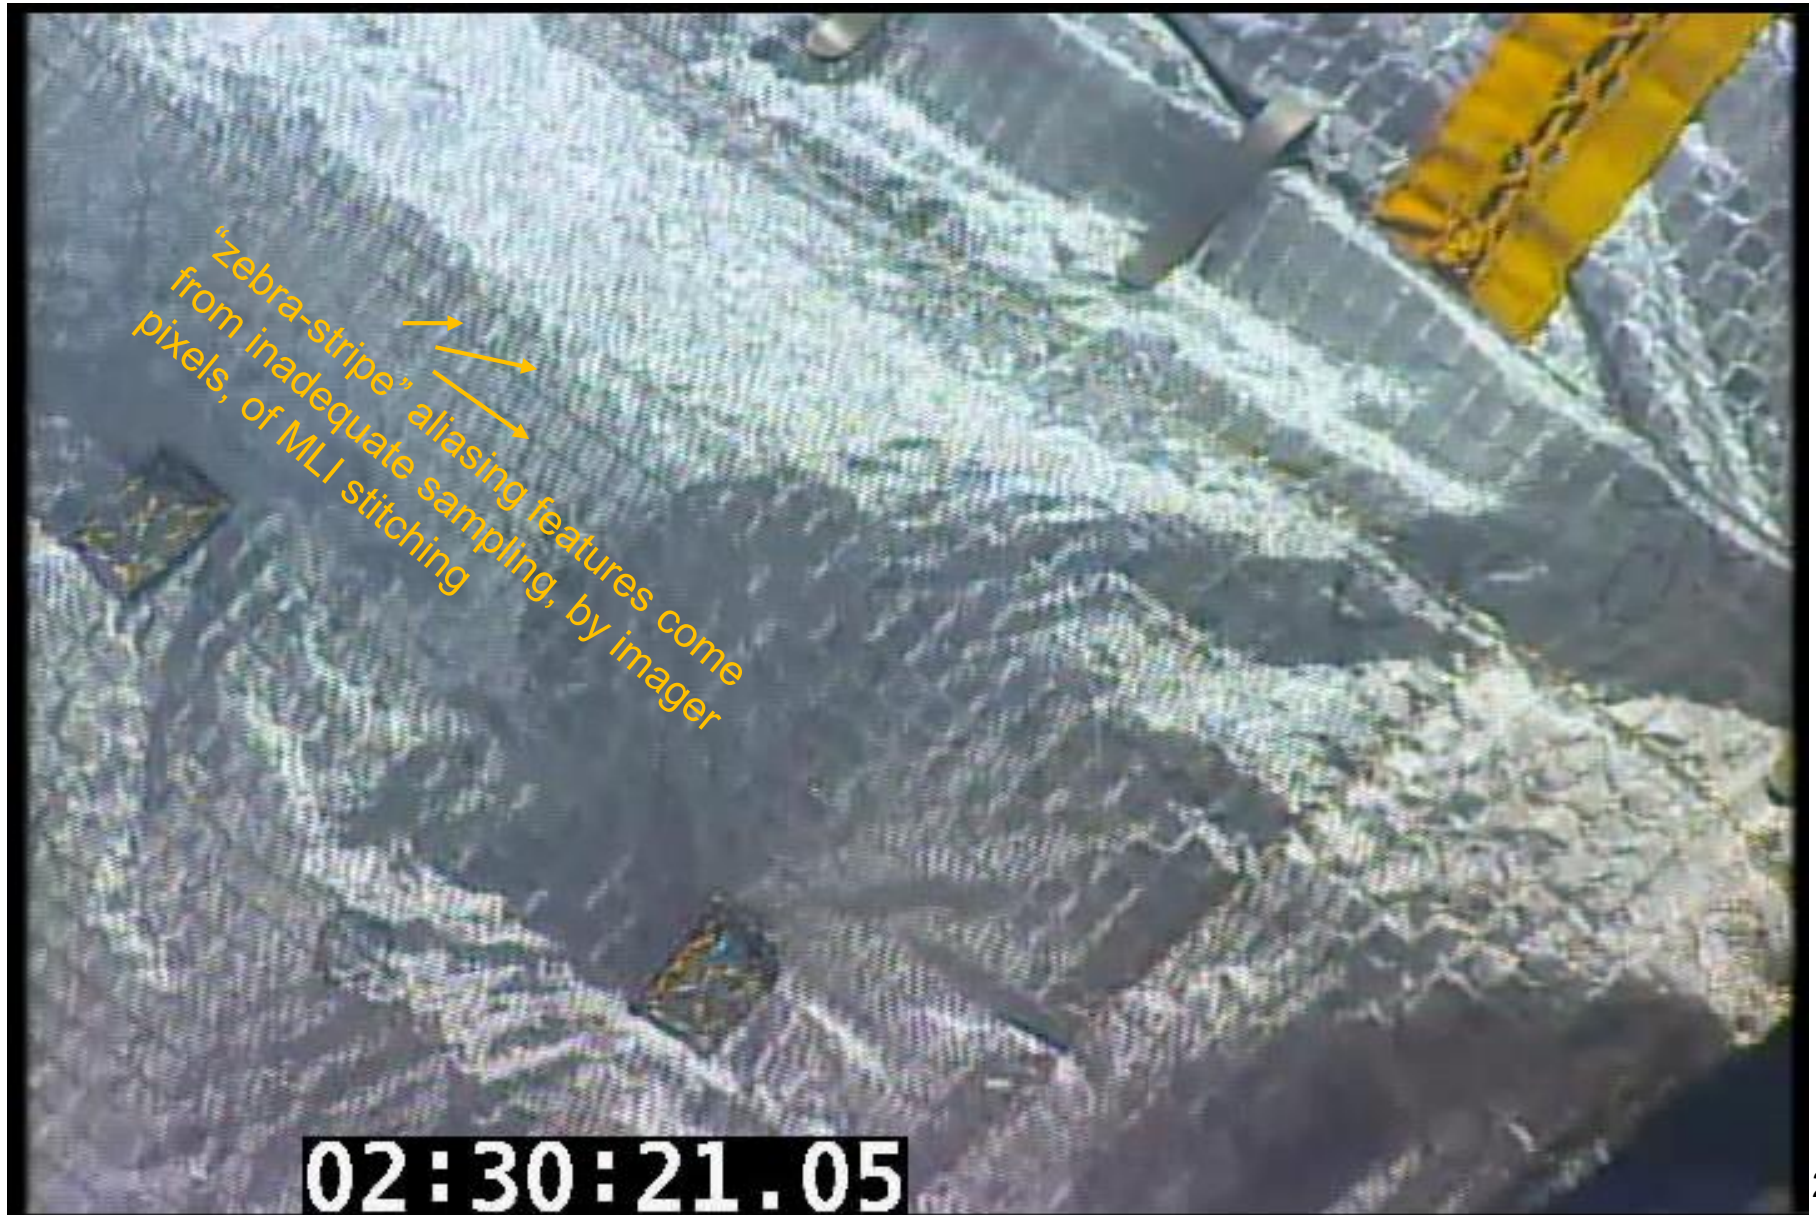
# Issue: Stitch Aliasing

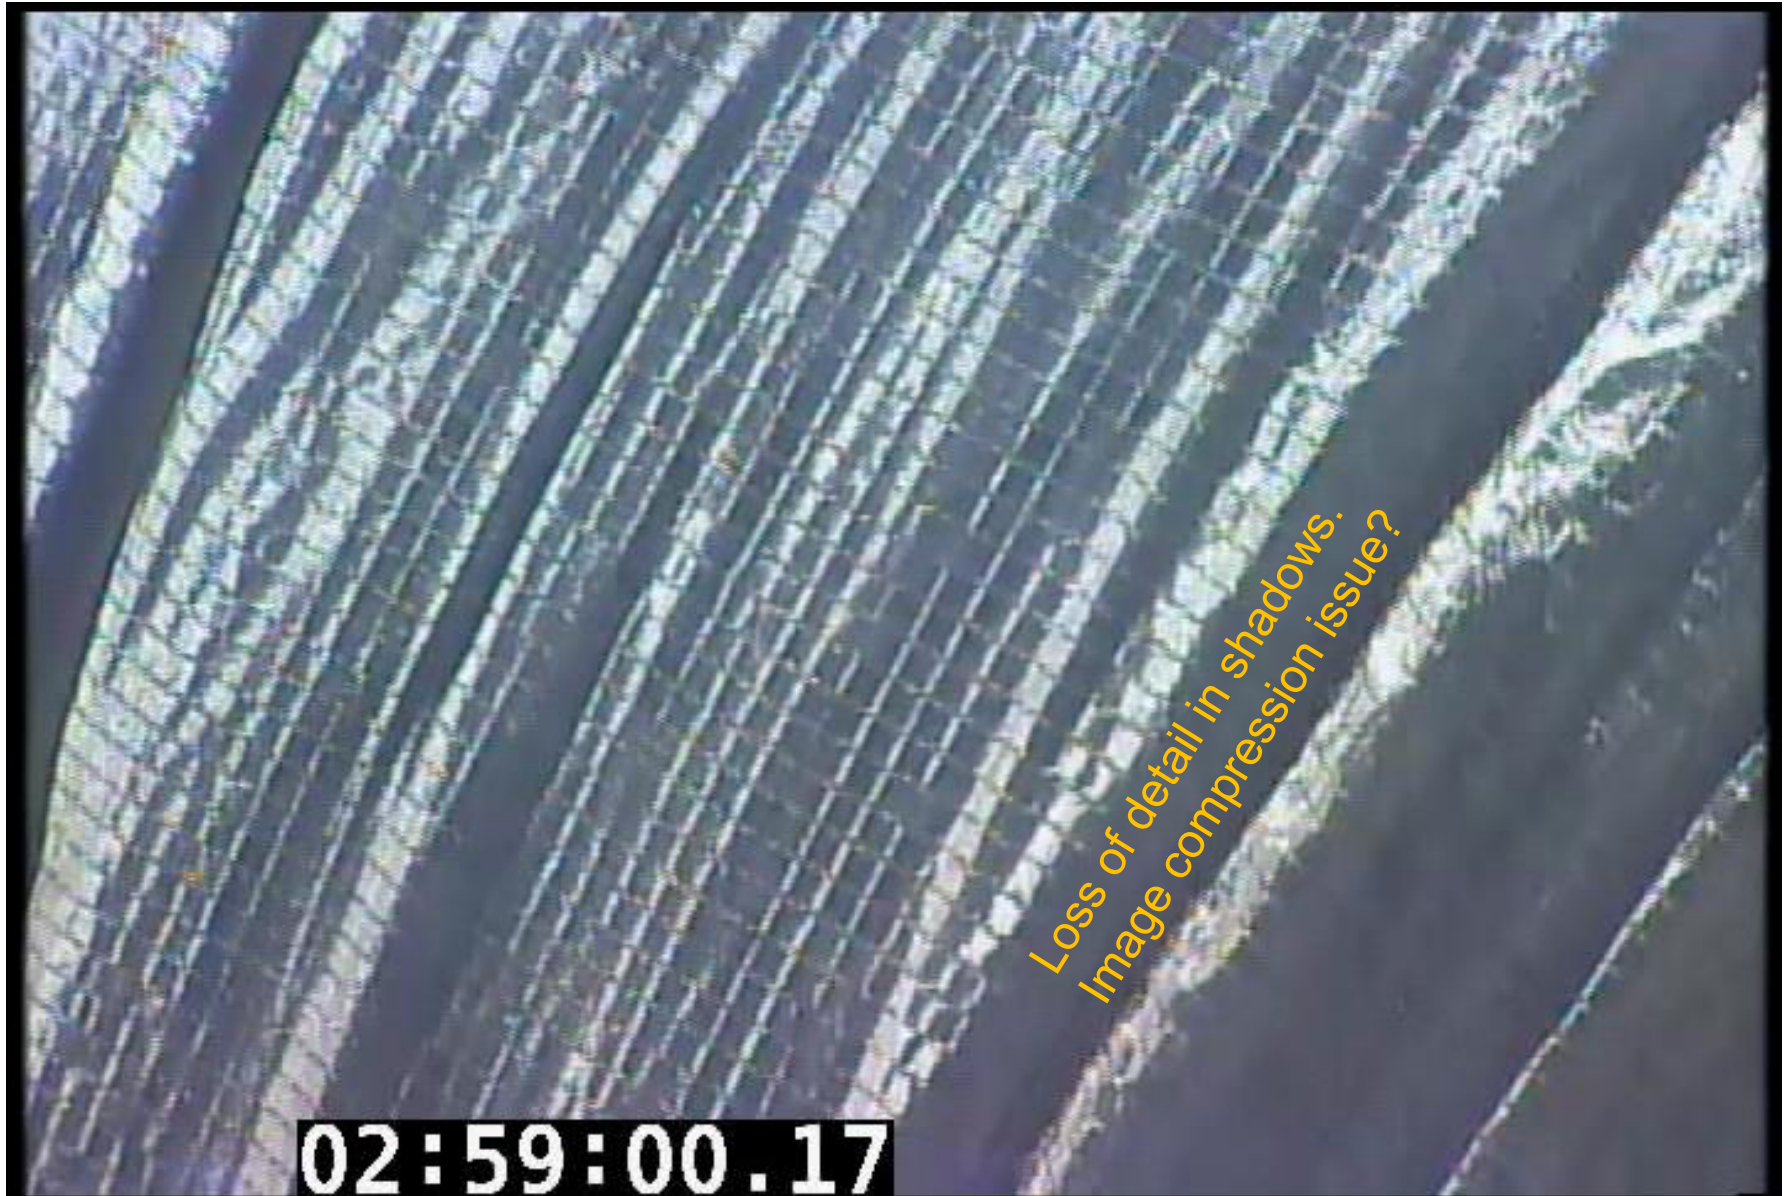
# Issue: Loss of Detail in Shadows

Loss of detail in shadows.  
Image compression issue?
